# Renovation Study

## Chewelah Commercial Facility

# Scope

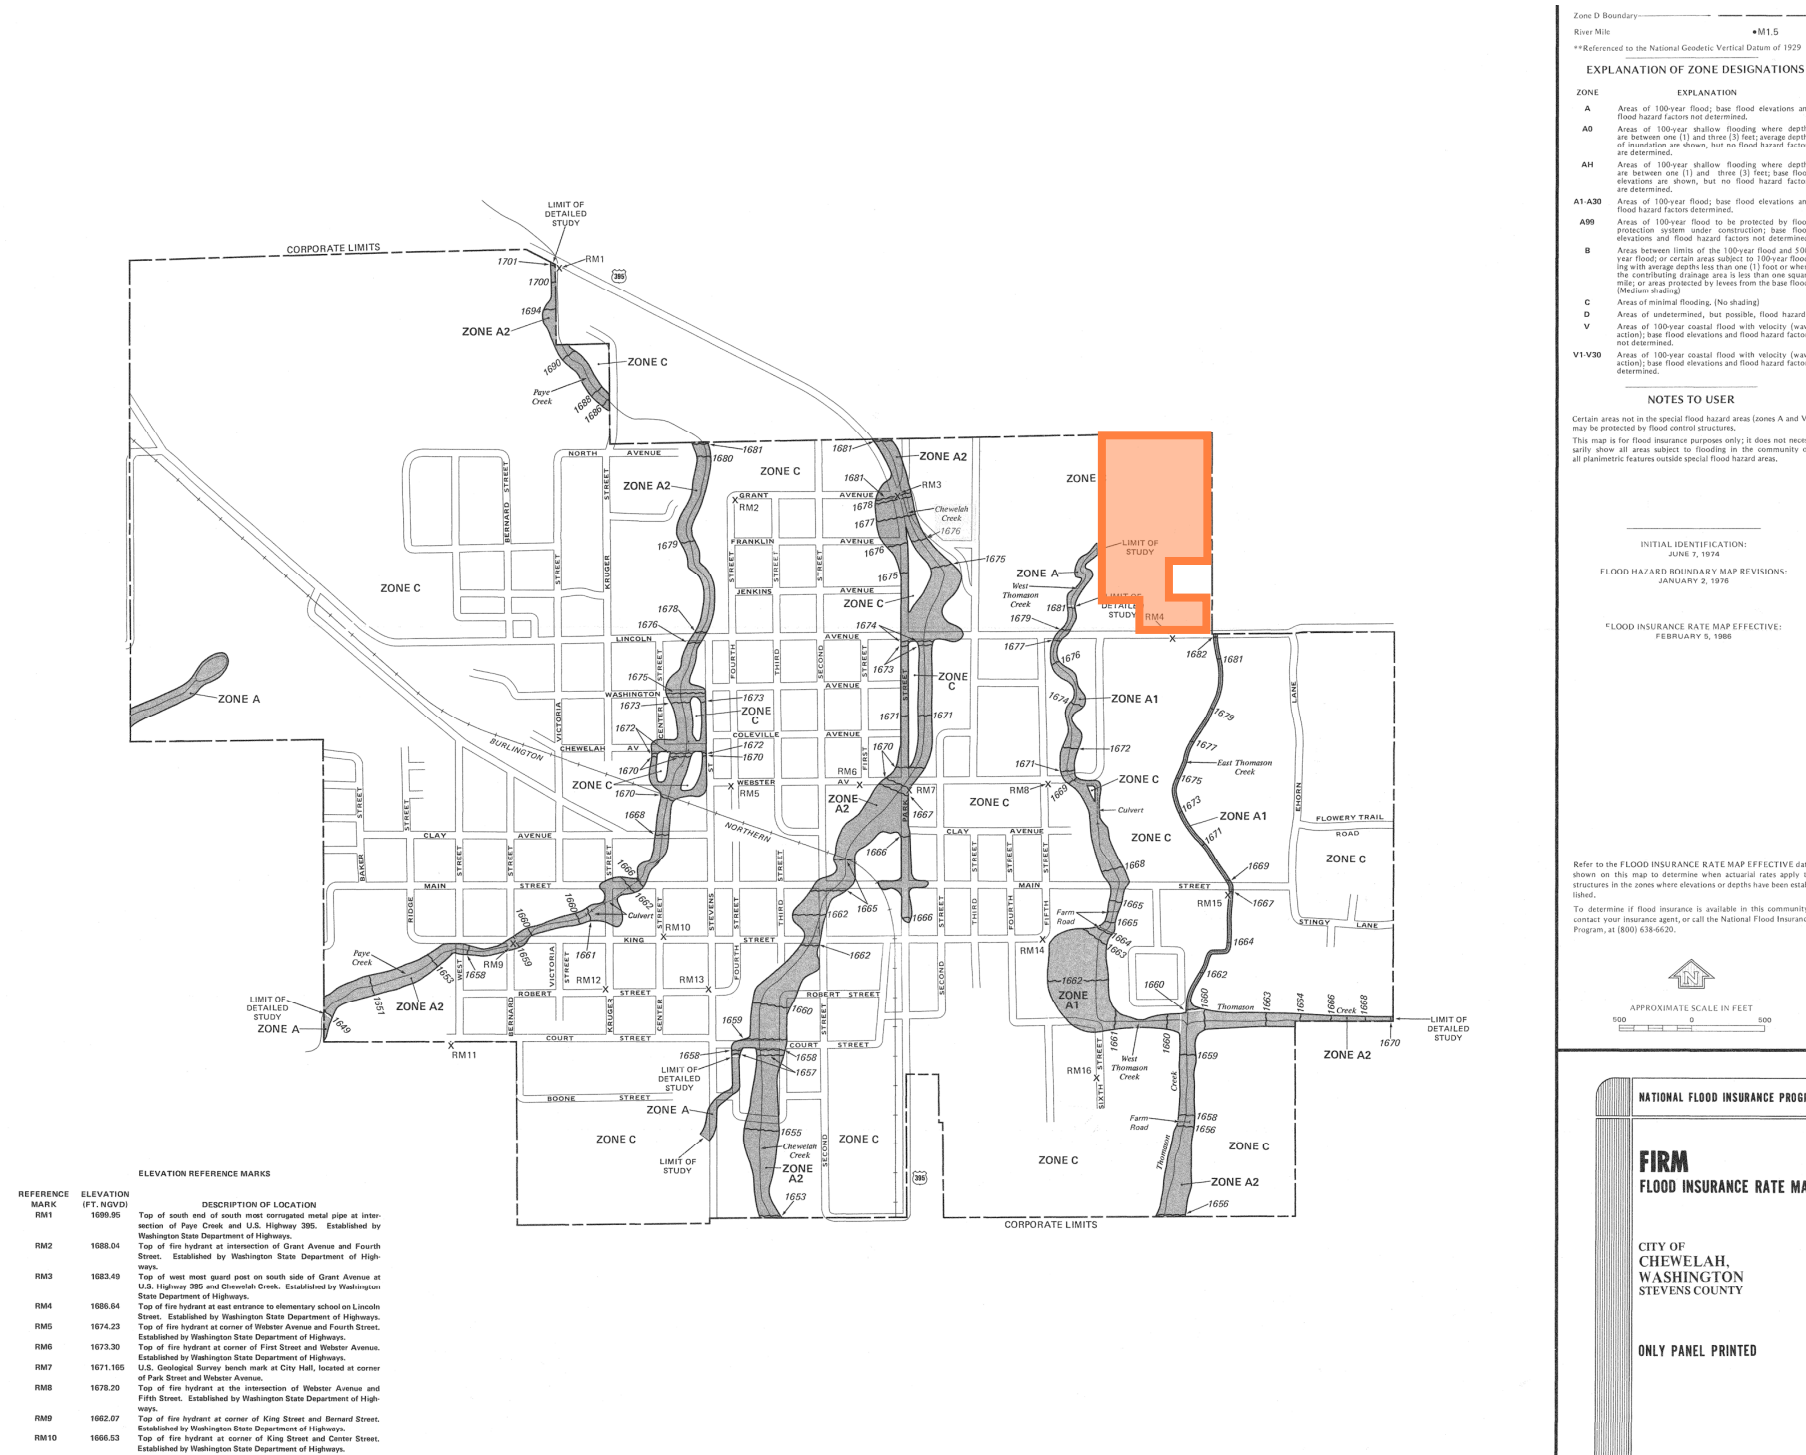
## Appendix D - Civil Assessment - Exhibit A

- Overall the site slopes from north to south.
- Land Use and Zoning - See Appendix B.
- Critical Area
  - Floodplain (Appendix D - Exhibit A)  
The site is predominately a Zone C floodplain which does not have any special restrictions

- An unnumbered zone A floodplain is located west of the site and likely coincident with the stream. Further analysis would likely indicate the floodplain would be located on the site. The cost to develop in the floodplain generally exceeds the benefit.

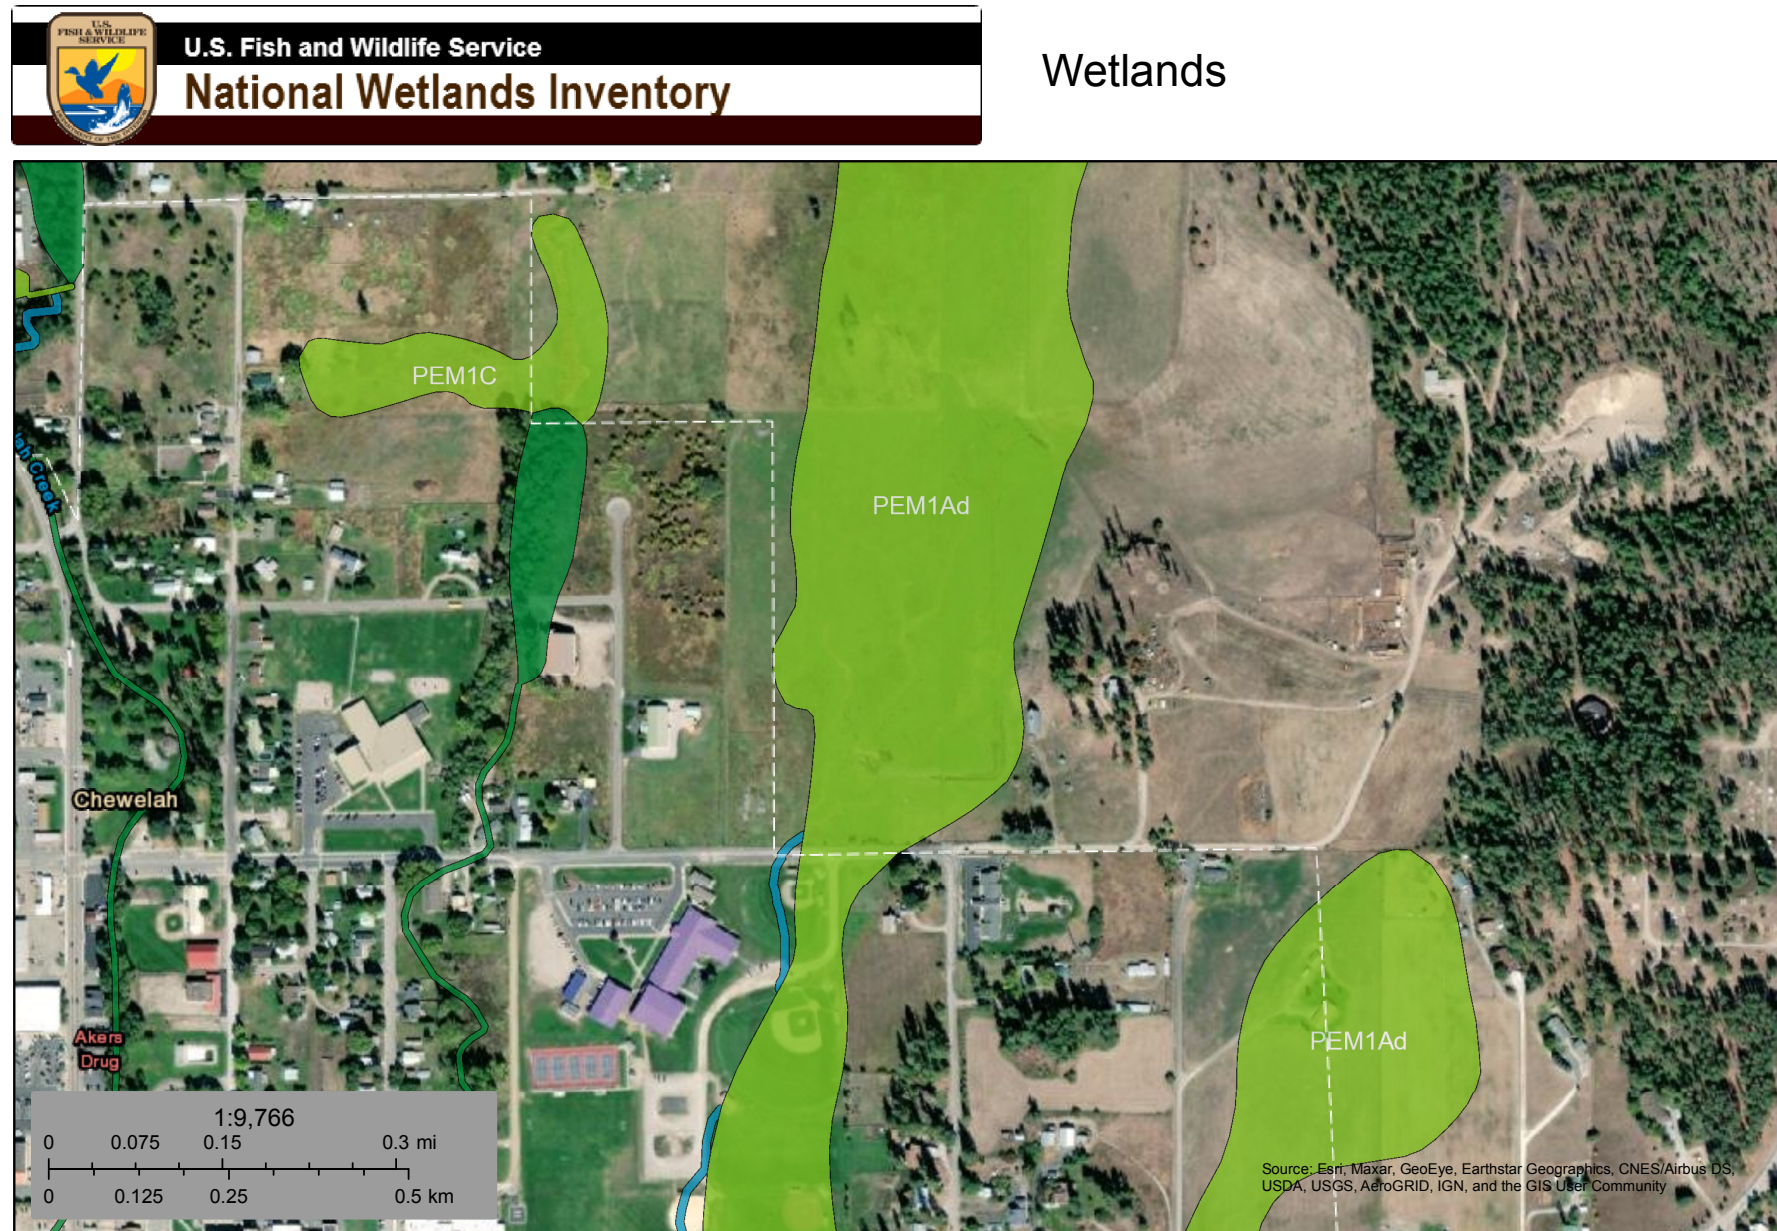
Appendix D - Civil Assessment - Exhibit B

- Zone A floodplains are also known as, floodplains, 100 year floods and 1% annual chance event in regulatory terms.
- Wetlands
  - The National Wetlands Inventory (Appendix D Exhibit B) indicates wetlands located on the stream to the west of the project.

- Wetland permits are generally reviewed by Ecology, reducing local agency direction and impact.
  - The wetlands are considered a Category II wetland which has a buffer of 150 feet per Stevens County Code. An additional 10 foot buffer is required for building setbacks. This buffer should be reviewed and confirmed by a wetland biologist.

- Buffer averaging should be explored, which allows development within a wetland buffer by dedicating additional property, usually double the impacted buffer, elsewhere on the site.

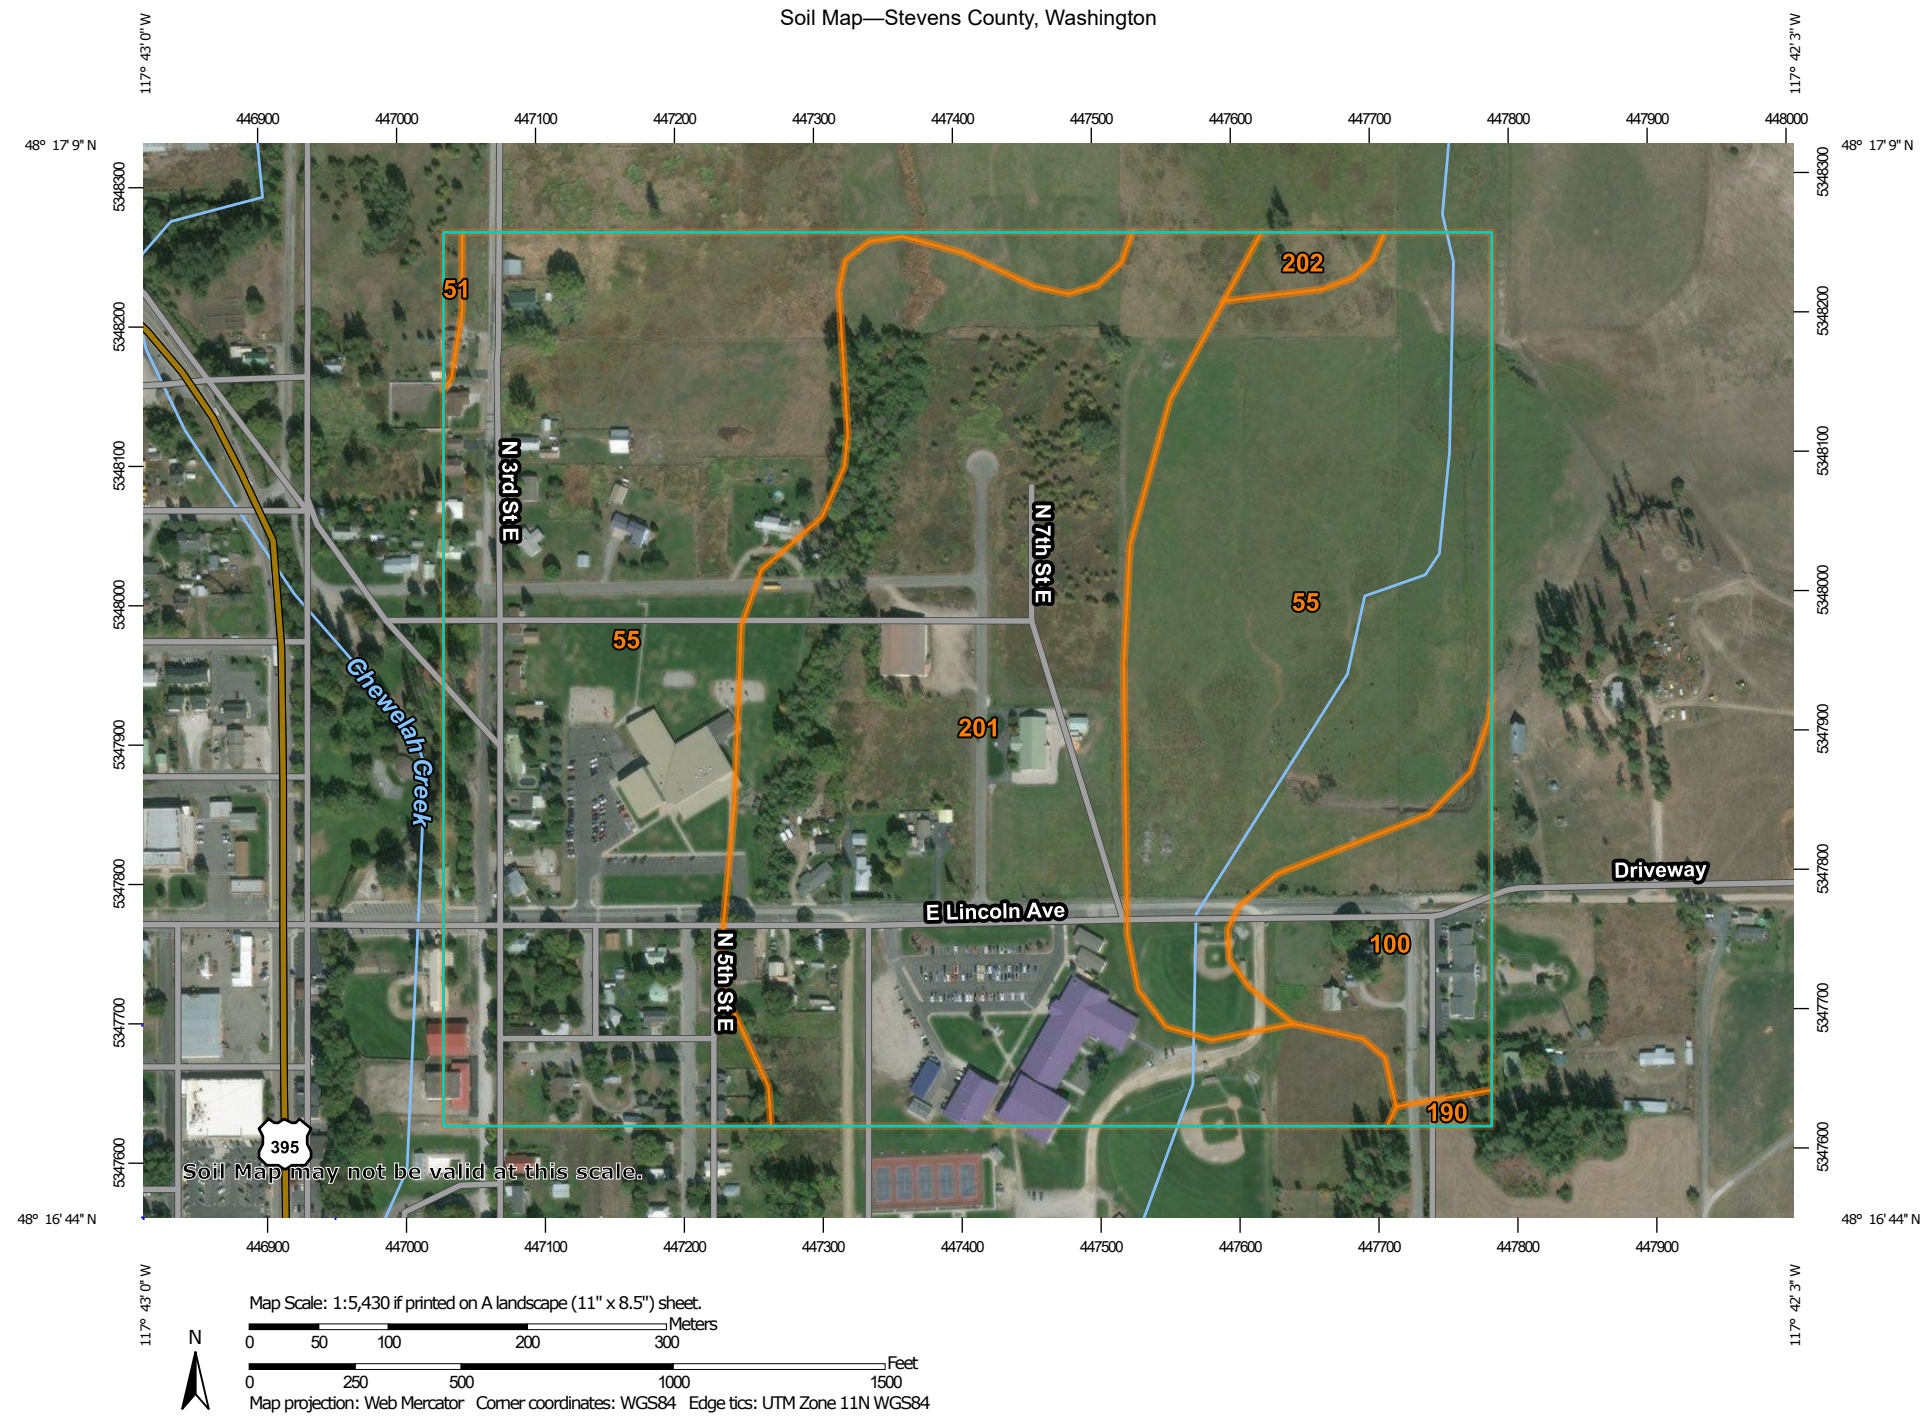
## Appendix D - Civil Assessment - Exhibit C

- Soils
  - The site is predominately mapped as "saltese muck", which is generally described by the NRCS as follows: The soil is likely to be difficult for re-use as structural fill on-site due to the fine-grained nature and also the potential for saturation. See appendix D Exhibit C.

- Slopes are 0 to 2 percent. This component is on depressions. The parent material consists of organic material mixed with alluvium, diatomite and volcanic ash. Depth to a root restrictive layer is greater than 60 inches. The natural drainage class is very poorly drained. Water movement in the most restrictive layer is moderately high. Available water to a depth of 60 inches (or restricted depth) is very high. Shrink-swell potential is low. This soil is not flooded. It is frequently ponded. A seasonal zone of water saturation is at 0 inches during February, March, April, May.
